# CANISTEAR RESERVOIR DAM

NO 2

NJ 00561

## PHASE 1 INSPECTION REPORT NATIONAL DAM SAFETY PROGRAM

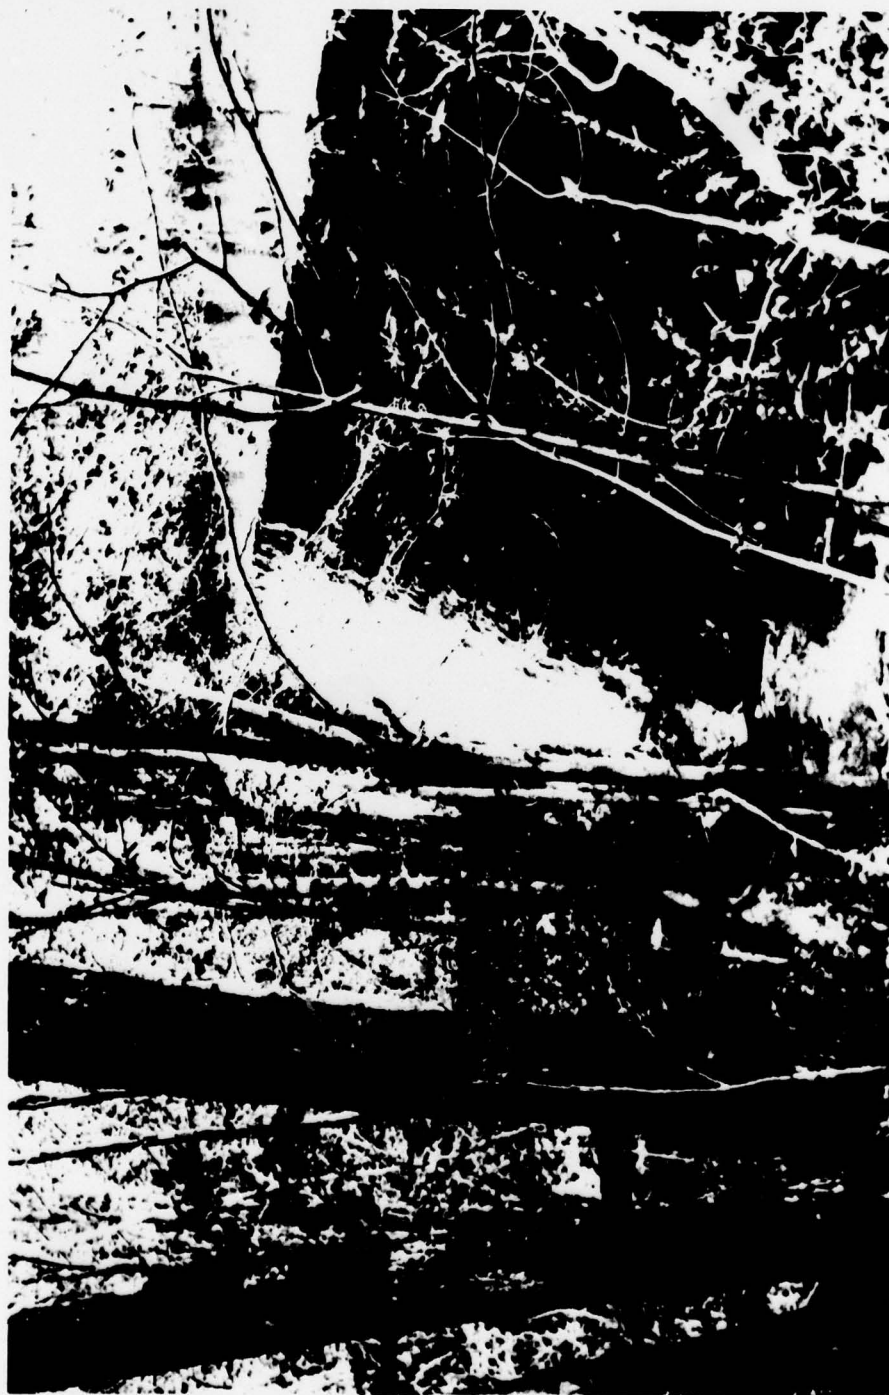
OVERVIEW OF CANISTEAR RESERVOIR DAM NO. 2

Canistear Reservoir Dam No. 2 is assessed to be in a fair overall condition and it is recommended that it be downgraded to a significant hazard category. No detrimental findings were uncovered to merit further study. The spillway is adequate to accommodate the design flood. Recommended remedial actions to be undertaken in the future include repointing all exposed stone masonry and repositioning and reanchoring the spillway capstones where required.

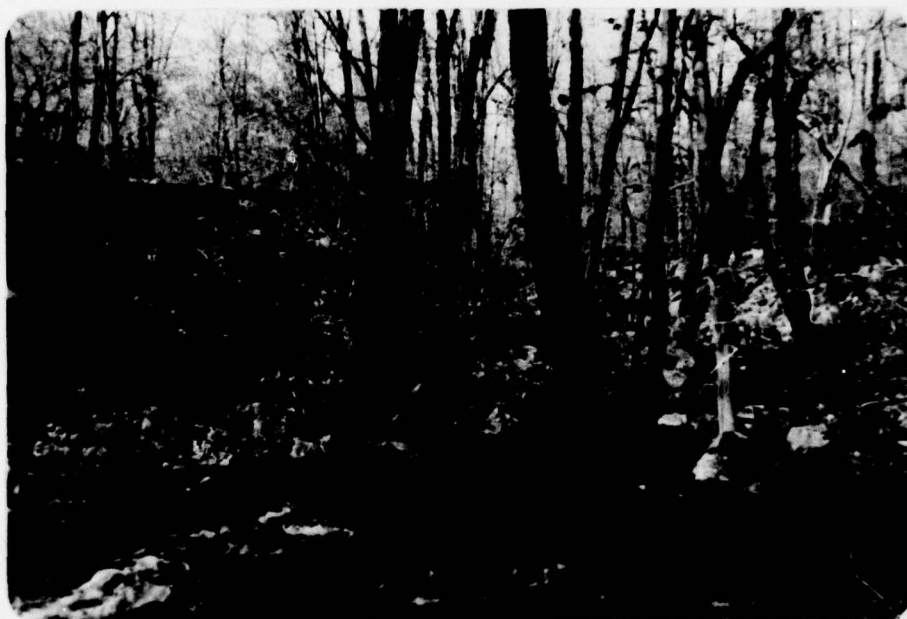
View of Discharge Channel
